Star Restoration

Claim Summary

Water damage

Initial Inspection 4-18-2022 BT

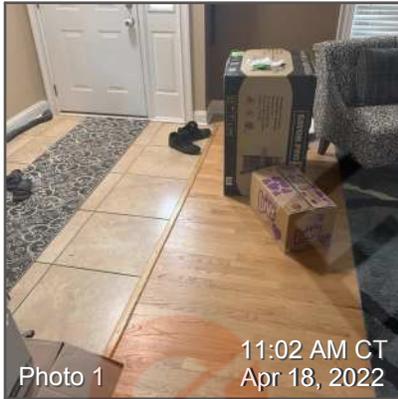
Photo 1

Remove impacted hardwood flooring (severely cupped)

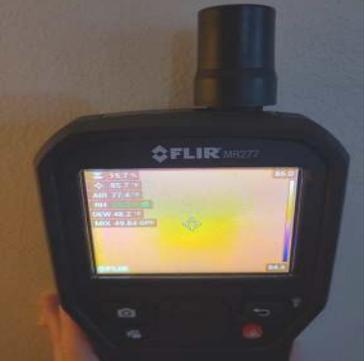
| # | Time | Meter | Moisture Content | Surface Temperature | Notes & Photos |
|---|---|---|---|---|---|
| 2 | Nov 3, 3:37 PM | Flir 100% | 49% | | |

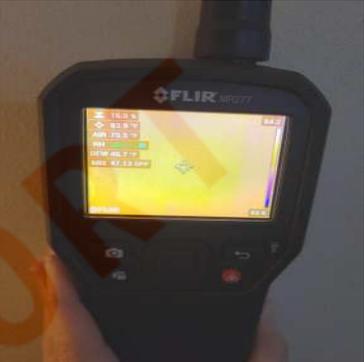
| # | Time | Meter | Moisture Content | Surface Temperature | Notes & Photos |
|---|---|---|---|---|---|
| 3 | Nov 4, 4:51 PM | Flir 100% | 6% | | |
